MODEL: ComColor 90xx, 70xx & 30XX

DATE 28 May., 2009

SUBJECT: Malfunction to close the Front Cover

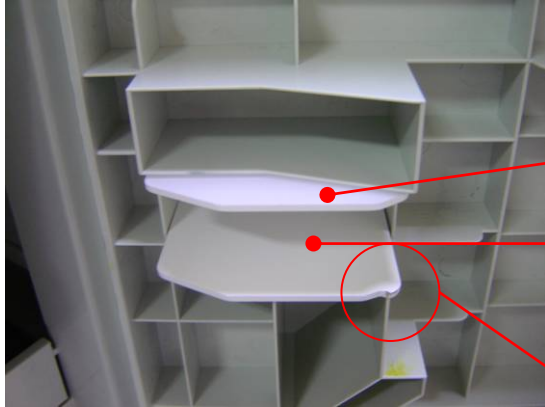
3. C1 Area

050-34119 Plate U; C1

050-34115 Plate L; C1

Notch

Stick the Plate U; C1 & Plate L;C1 on the Front Right Cover.
